Cinquantotto Reservoir Sensor

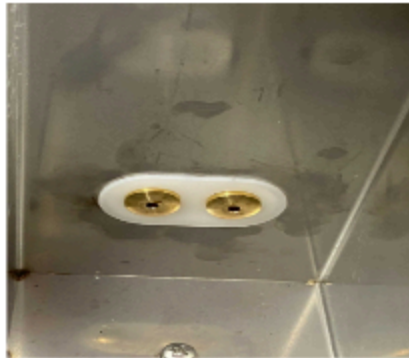
- This is a capacitive sensor which requires mineral content in the water to complete the circuit.
- There are two bolts on the reservoir that line up with two bolts inside the reservoir holder.

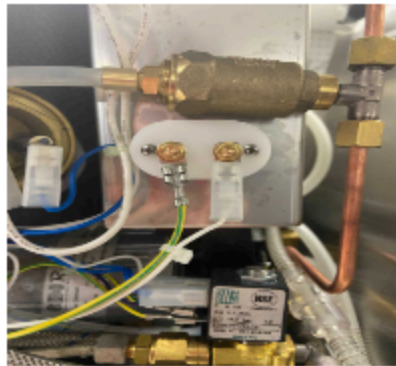
- If there is no water being sensed and the water is determined to have proper mineral content for conductivity then it is possible that one of the wires on the back side of the assembly has been disconnected.

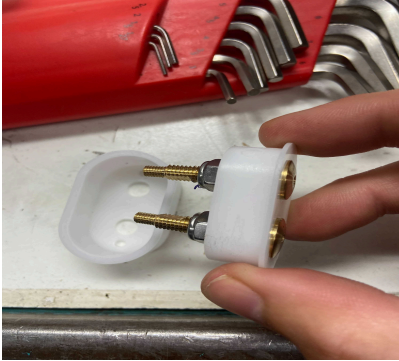
- It is also possible that the bolts on the reservoir are not making full contact with the contactor device on the reservoir holder. An indicator that this is occurring is when the unit only recognizes there is water when the reservoir is tilted towards the contactor. These are the steps to adjusting the contactor:
 - Remove the right side panel of the machine.
 - Use a 7mm wrench and 2.5mm allen wrench to remove the terminal connectors from the terminal.

- Use a small philips head screwdriver to remove the two screws from the back side of the assembly.
- The assembly will now separate into two halves.

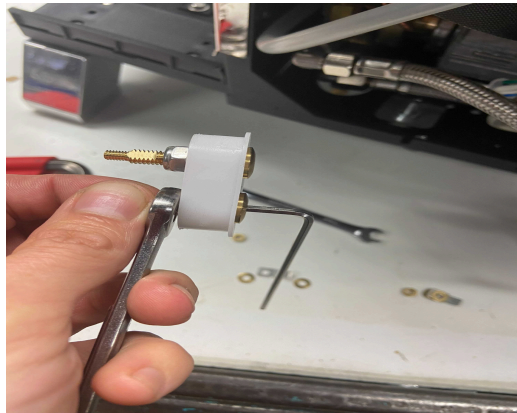
- Note: the assembly has tension springs which will cause the contactor screws to push inward when seating the reservoir. It is important to ensure that the threaded posts are not touching the white housing during reassembly as this can cause the post to hang up and stay seated back away from the reservoir.

- Use a 10mm wrench to hold the silver nut and the 2.5mm allen wrench to turn the screw counter clockwise to expose more of the contactor screw.
