Solis of Switzerland

Steam wand repair

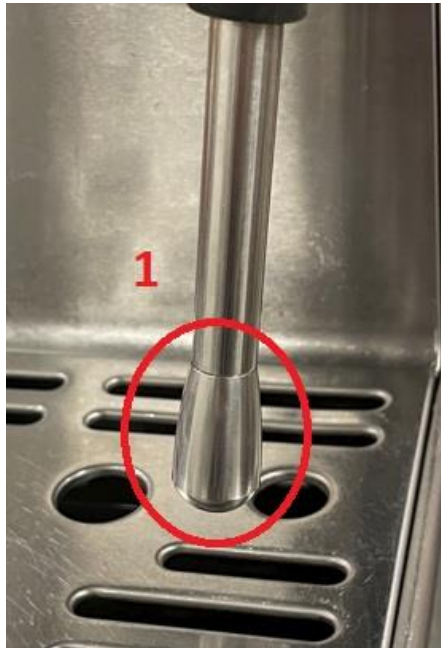
Unscrew the nozzle of the steam wand (1). Check if the O-ring is inside the nozzle and verify that it is not damaged (2). If the O-ring is missing or damaged put it on/replace it.

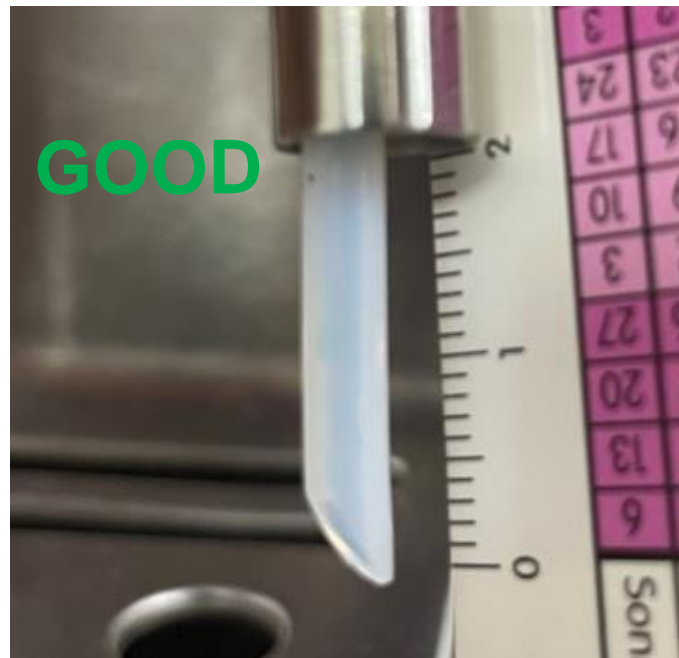
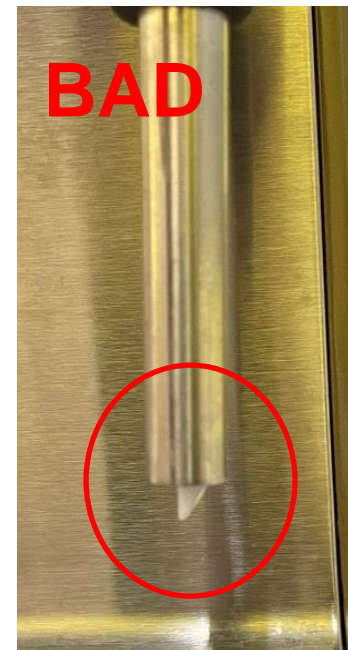
**Check if the inner steam tube is in the right position or not. If it's in position, screw the nozzle and test again the machine (follow the procedure on user manual to make steam). Otherwise proceed with next step.**

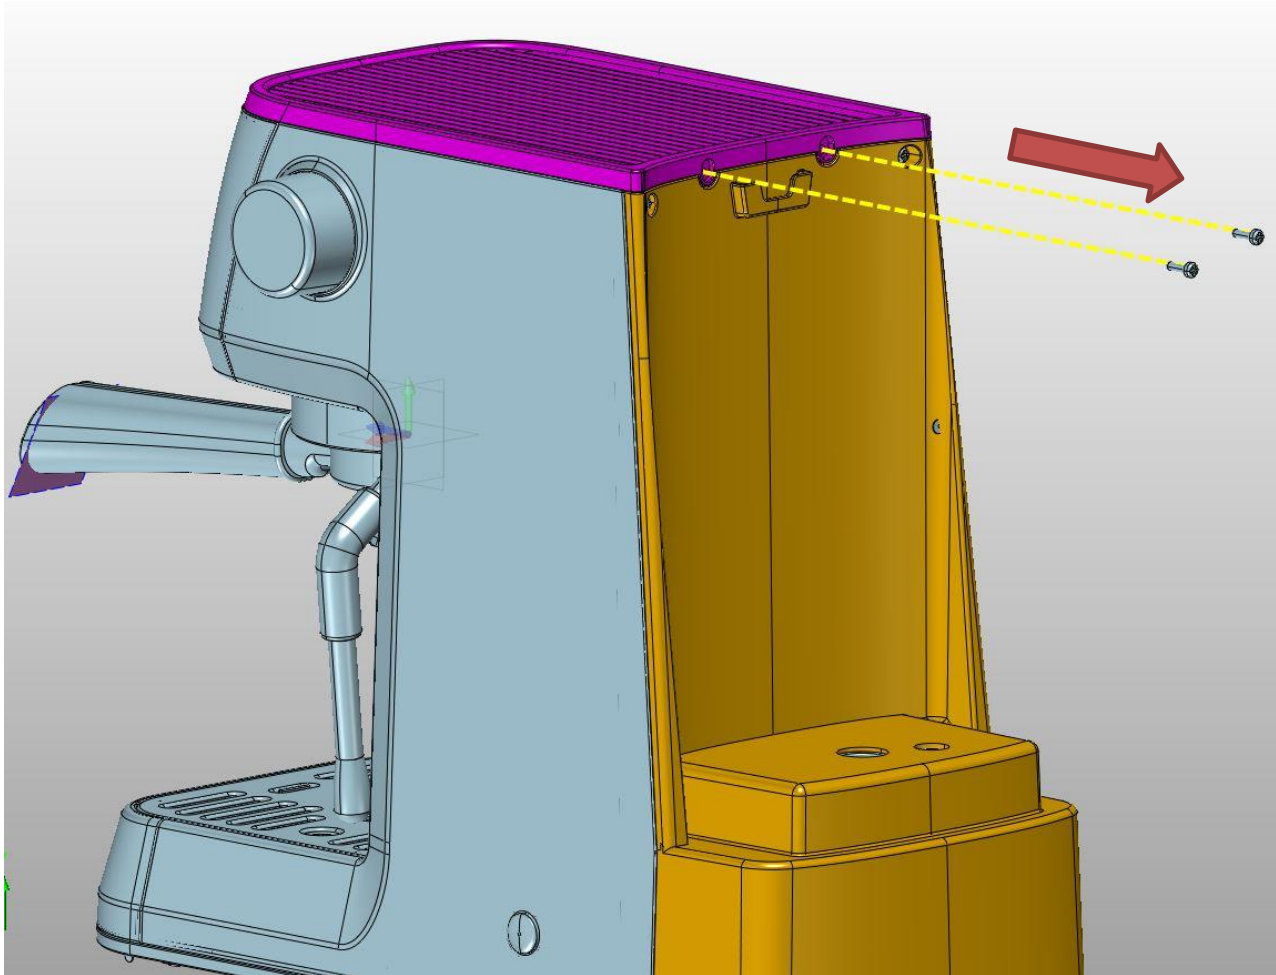
**Unscrew the screws  
of the top cover**

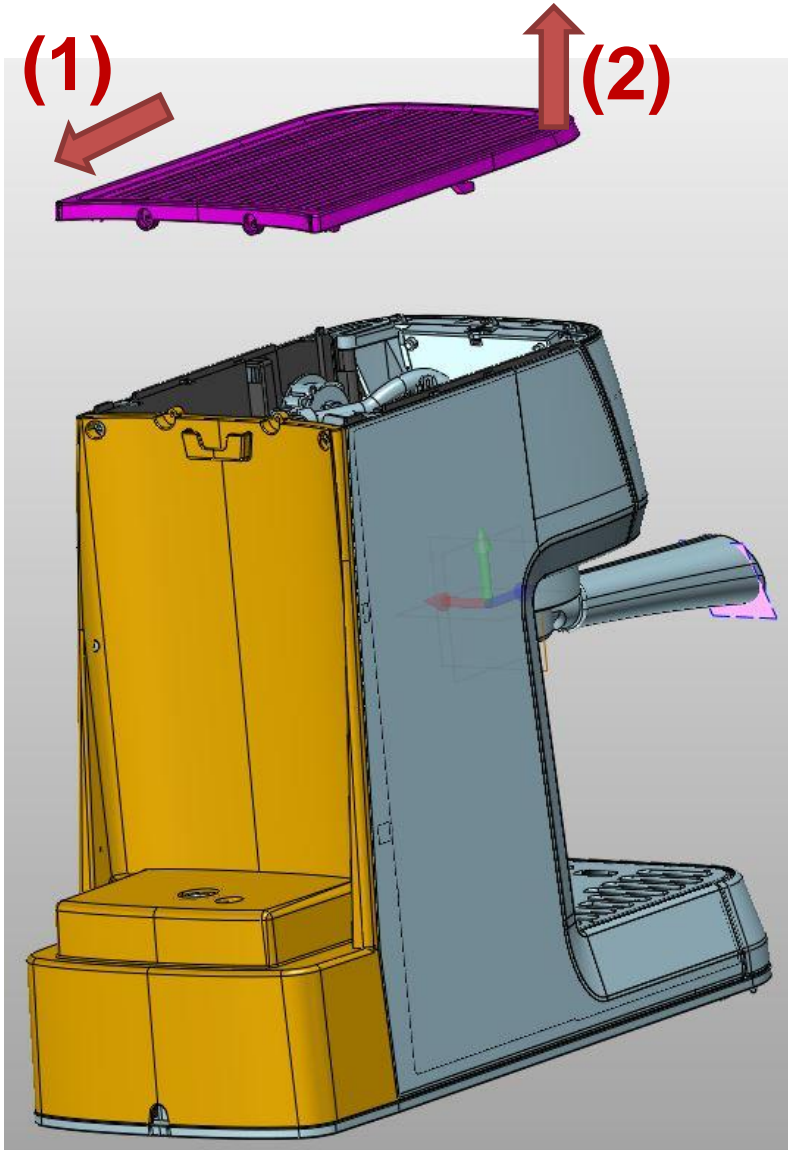
**Remove the top cover,  
dragging it toward the backside  
(1) and then pull it up (2)**

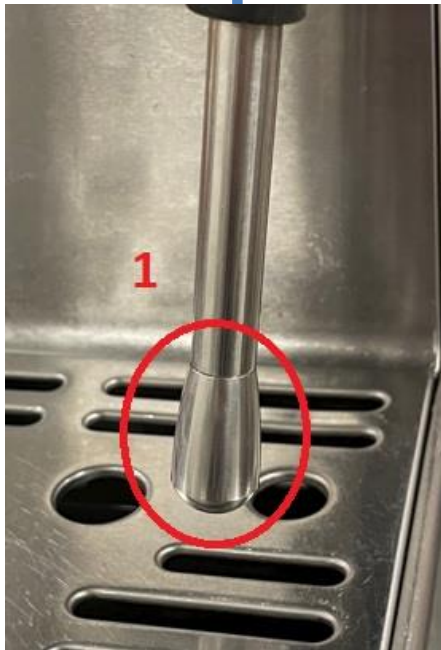
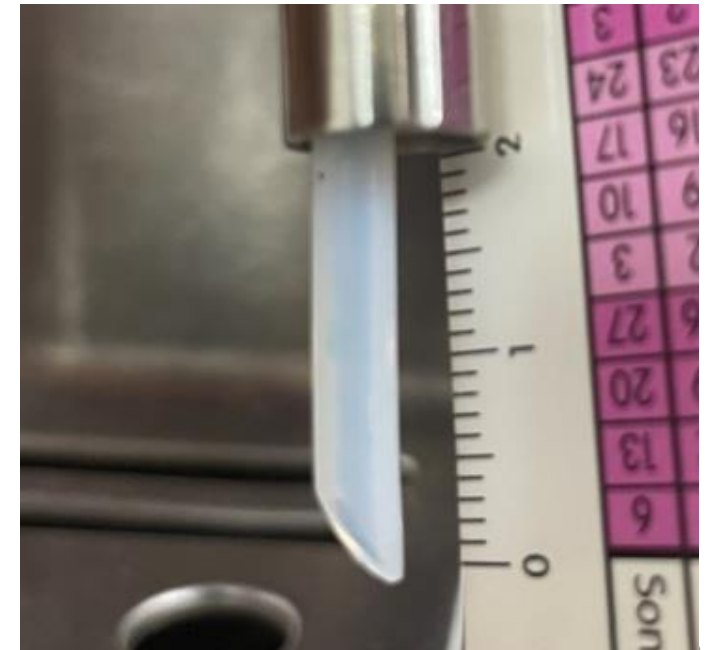
**Unscrew the nozzle of the steam wand (1). Check if the teflon tube is inside the steam wand (2). Push it out so that it protrudes 20 mm +/- 1mm.**
