How to Resolve Squeaking from the Boiler Spout on the Gaggia Anima Line of Machines

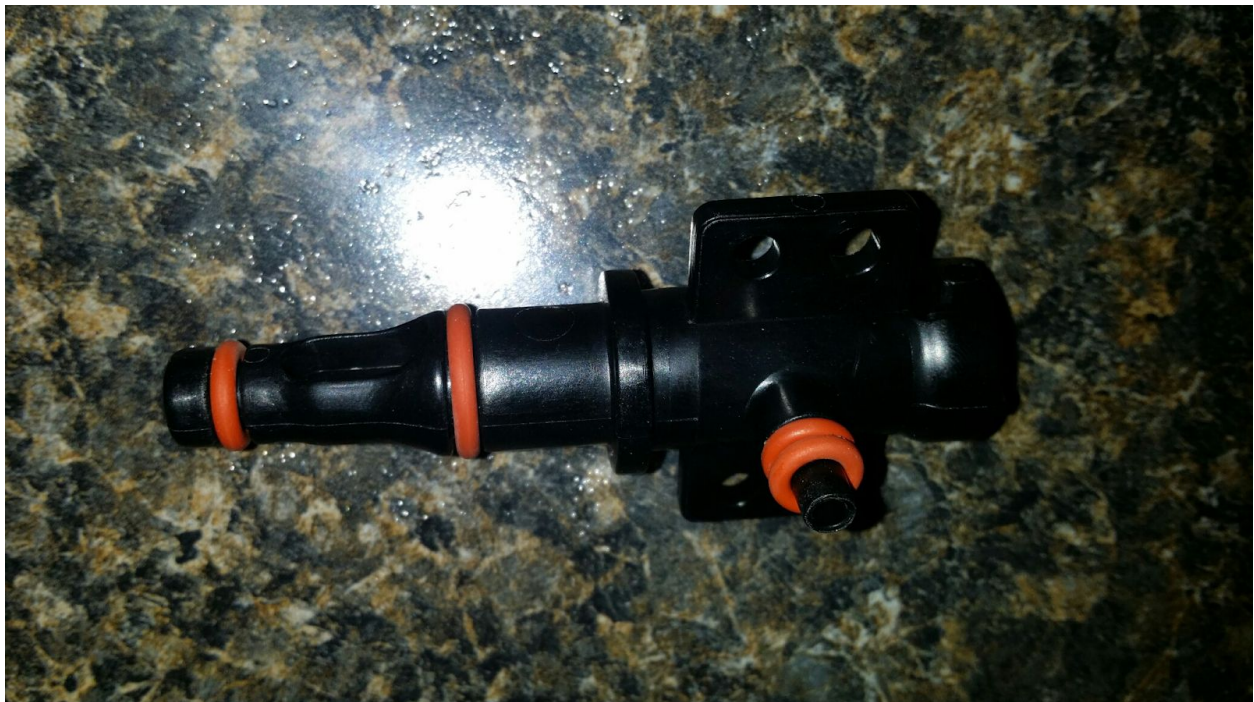
5. Remove the entire spout. Be careful, as there are 2 red o rings on the back side of this. If the o-rings come off and remain in the machine, use your allen key or a pick tool to hook them so you can remove them from the machine. The spout should look like this:
